Manhole Inspection Summary

Manhole # S37A2_004MH

Insp Date: **12/6/07 1:27 PM**

Location Address: **3918 4th St**

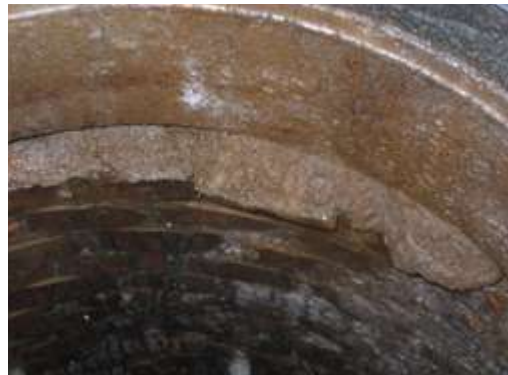
Defect 1

Condition: ☐ Sound ☐ Cracked ☐ Root Intrusion ☒ **Loose Brick** ☐ Deteriorated

loose bricks on chimney

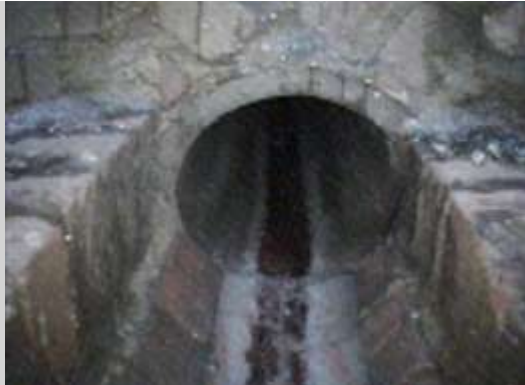
12 O'Clock Outflow

8 in. Circular Gravity Sewer
Pipe Out @ 12 O'Clock

Pipe Height: **7.2** (in.) Rod and Bar (Angled)
Pipe Material: **Clay** ☐ Pipe Lined
Invert Depth: **10.10** (ft.) Flow Characteristics: **Fast**
Deposits: ☒ None ☐ Mud ☐ Sludge ☐ Debris ☐ Grease
Silt Depth: (in.) Deposits Extent:
Infiltration: **None** Pipe Seal Cond: **Sound**

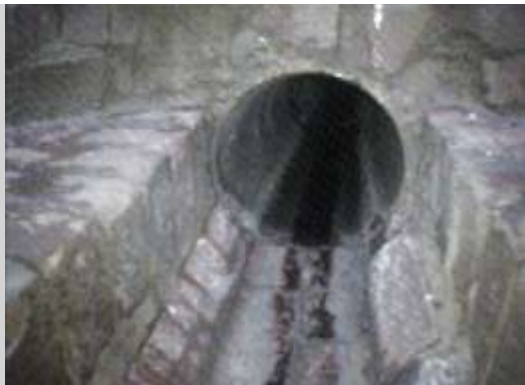
6 O'Clock Inflow

8 in. Circular Gravity Sewer
Pipe In @ 6 O'Clock

Pipe Height: **8.4** (in.) Rod and Bar (Angled)
Pipe Material: **Clay** ☐ Pipe Lined
Invert Depth: **9.88** (ft.) Flow Characteristics: **Fast**
Deposits: ☒ None ☐ Mud ☐ Sludge ☐ Debris ☐ Grease
Silt Depth: (in.) Deposits Extent:
Infiltration: **None** Pipe Seal Cond: **Sound**
